CNC EDM

Repair CNC EDM JOEMARS Brand.....

Manufacture : JOEMARS MACHINERY & ELECTRIC INDUSTRY CO.,LTD.

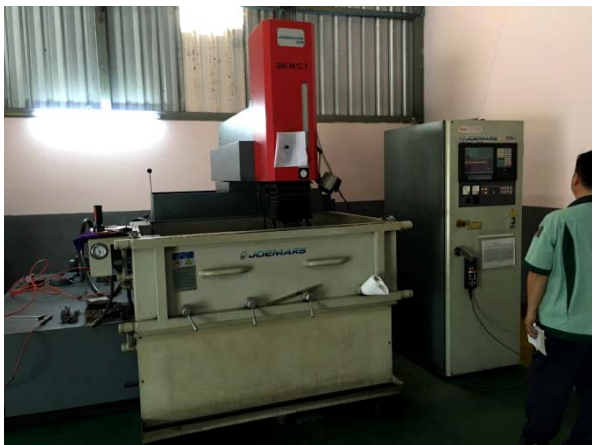
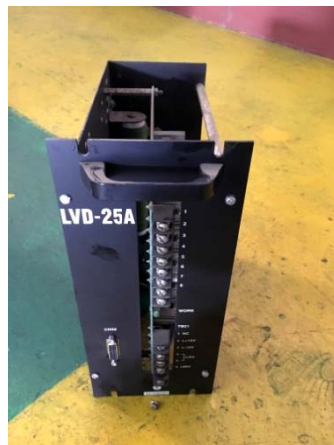
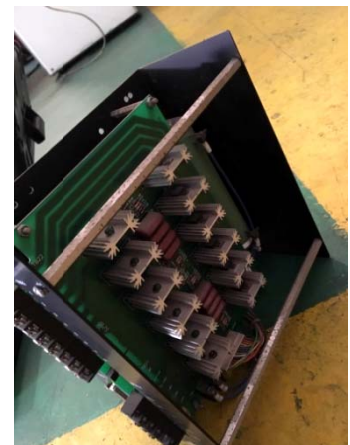
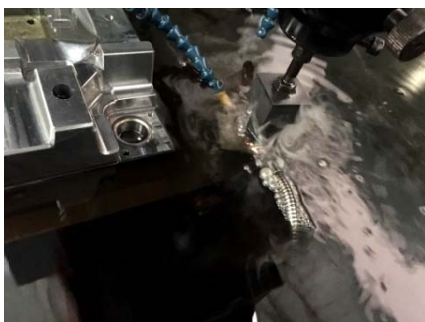
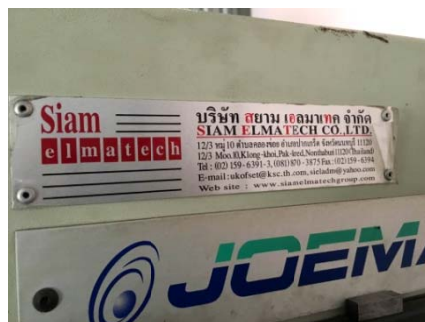
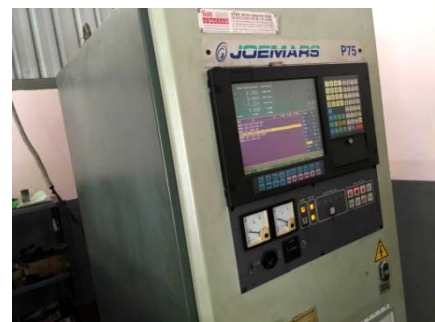
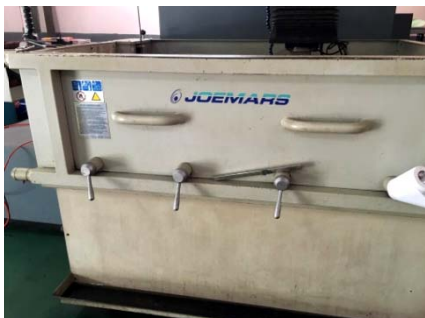
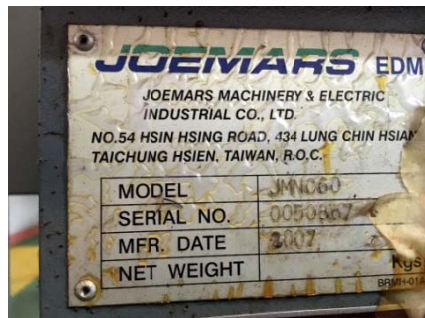
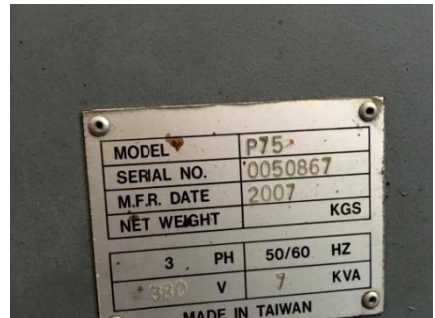
The problem was happened because of the electrical shut down during sparking. The Z Axis Servo drive unit and LVD-25A were damaged.
